Applies To: **1998-01 Prelude - ALL**

October 30, 2001

Prelude: MIL Comes On With DTC P0133

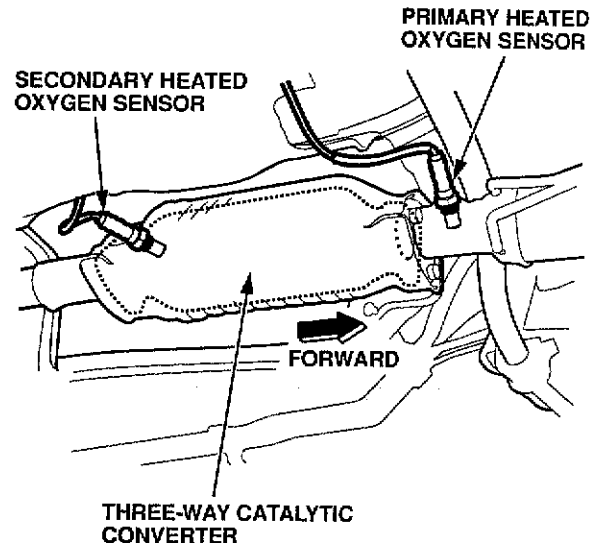
The MIL is on with DTC P0133 (primary heated oxygen sensor slow response) stored.

The primary heated oxygen sensor malfunctions.

1. Confirm the DTC with the PGM Tester.
2. Disconnect the primary heated oxygen sensor 4P connector.
3. Remove and replace the oxygen sensor with the appropriate part.

4. Reconnect the oxygen sensor 4P connector.
5. Use the PGM Tester to clear any DTCs.
