Applies To: 1997 Prelude Type SH – Thru VIN JHMBB6 . . . VC007624

March 17, 1997

ATTS Light On / DTC 78: Vehicle Inventory Update

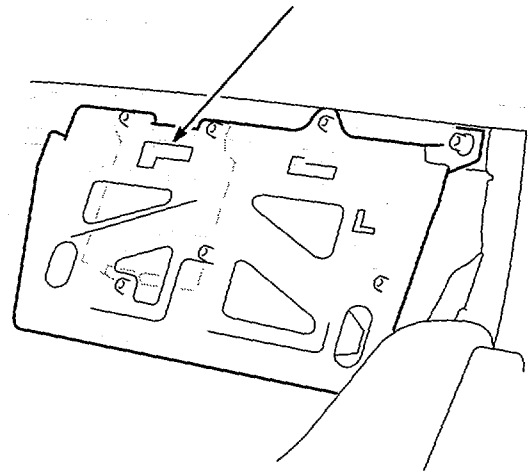
ATTS CONTROL UNIT
P/N 48310-P5P-003 = Replace
or
P/N 48310-P5P-013 = OK

- If the part number is 48310-P5P-013, it is an updated unit. Reinstall all removed parts, and return the vehicle to the customer.
- If the part number is 48310-P5P-003, it is not an updated unit. Continue to **Control Unit Replacement**.
