Applies To: 1997 Prelude – Thru VIN JHMBB6... VC015345

February 9, 1998

Squeaking Seat

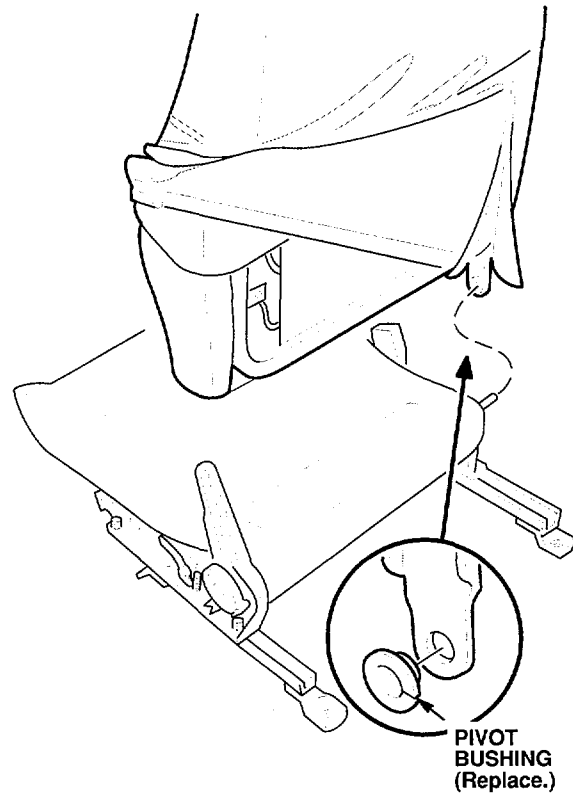
The bushing at the seat pivot is loose.

9. Remove the pivot nut (on the console side of the seat-back).

10. Remove the original pivot bushing, and install the new bushing.
