Applies To: 1997-99 Prelude - ALL

Moonroof Rattles When Open

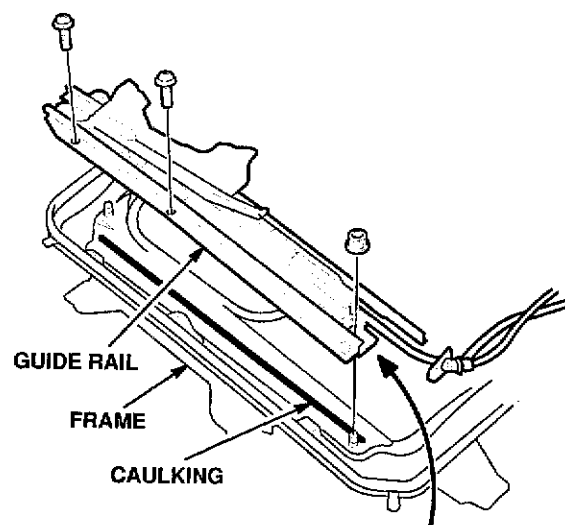
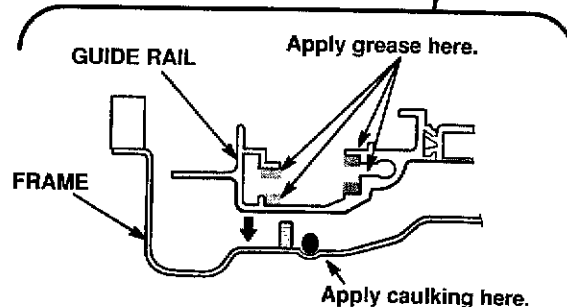
The guide rails have too much free play.

1. Remove the headliner (see page 20-43 of the 1997-99 Prelude Service Manual).
2. Remove the moonroof glass (see page 20-34). Note the number and location of shims (if any) when removing the glass.
3. Remove the frame (see page 20-35).
4. Remove the moonroof motor (see page 20-35).
5. Remove the drain channels (see page 20-37).
6. Remove and discard the guide rails (see page 20-37).
7. Apply 3M Strip-Calk to the guide rail mounting surfaces of the frame.

8. Apply Super High Temperature Urea Grease to the sliding surfaces of the new guide rails.
9. Install the new guide rails.
