SERVICE BULLETIN

HONDA

Model	Applicable To	File Under	Bulletin No.
1990 - 93 ACCORD COUPE	ALL	BODY	91-010
1992 - 93 PRELUDE			Issue Date JUNE 10, 1993

Partially Open Window Rattles (Supersedes 91-010, dated August 13, 1993)

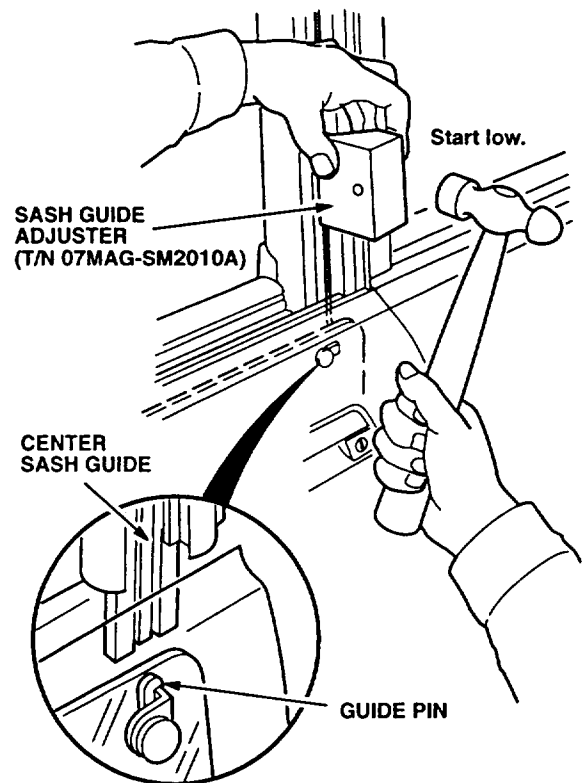
Accord - Excess clearance between the window guide pin and center sash guide, or the glass run channel has come out of the lower center sash guide.

2. Roll the window all the way down. Insert the Sash Guide Adjuster (T/N 07MAG-SM2010A) in the lower half of the center sash guide slot; then hit the tool with a ball peen hammer.

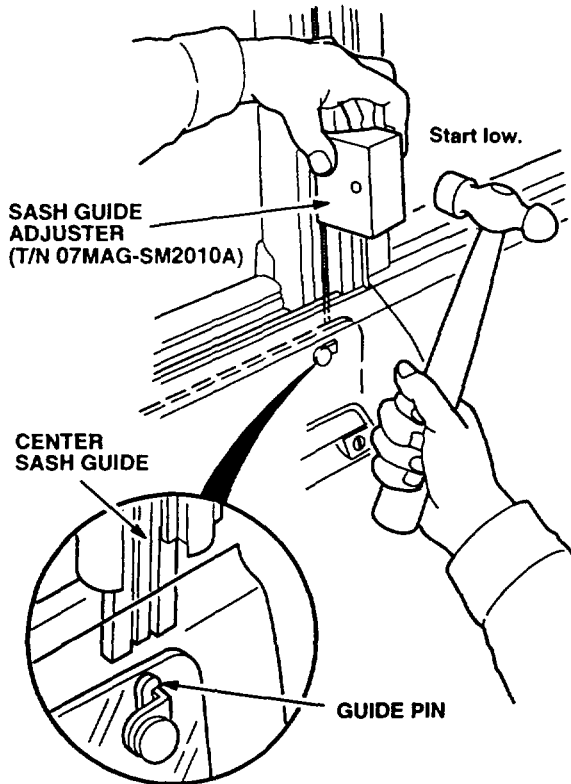
Prelude - Excess clearance between the window guide pin and center sash guide.

- Roll the window all the way down. Insert the Sash Guide Adjuster (T/N 07MAG-SM2010A) in the lower half of the center sash guide slot; then hit the tool with a ball peen hammer.
