SERVICE BULLETIN

Model 1992 PRELUDE	Applicable To ALL	File Under BODY	Bulletin No. 92-028
			Issue Date AUG 28, 1992

Squeaking From Closed Sunroof

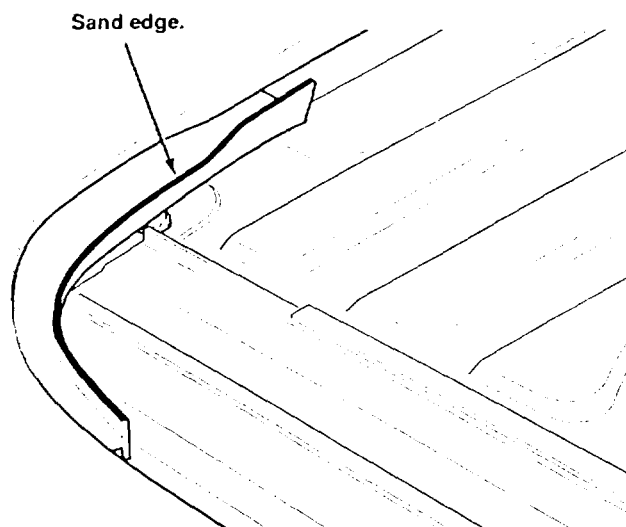
Interference between the sunroof panel and the rear drain channels. In most cases the rear corners of the sunroof panel sit below the roof panel.

3. Sand the edge of the rear drain channel on the side that squeaks to remove any high spots.
