# SERVICE BULLETIN

Model	Applicable To	File Under	Bulletin No.
1992 - 95 PRELUDE 1992 - 93 CIVIC 4-DOOR	See VEHICLES AFFECTED	BODY	92-047
			Issue Date
			OCT 24, 1994

## Rearview Mirror Reinstallation (Supersedes 92-047, dated November 30, 1992)

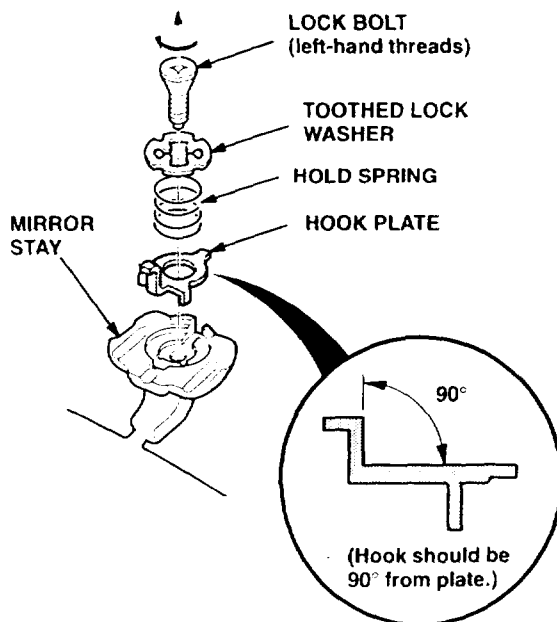
The rearview mirror may be accidentally knocked off the windshield lug and some of the internal parts can be broken or lost.

1. Remove the lock bolt from the mirror stay as described in the appropriate service manual.
2. Inspect the hook plate. If the hook plate is distorted, bend it to its original 90° position.
