SERVICE BULLETIN

HONDA
AUTOMOBILE SERVICE DEPARTMENT

Model	Applicable To	File Under	Bulletin I
1988 - 93 PRELUDE	ALL	BODY	93-00
			Issue Date
			FEB 12,

Jingling Noise From Rear

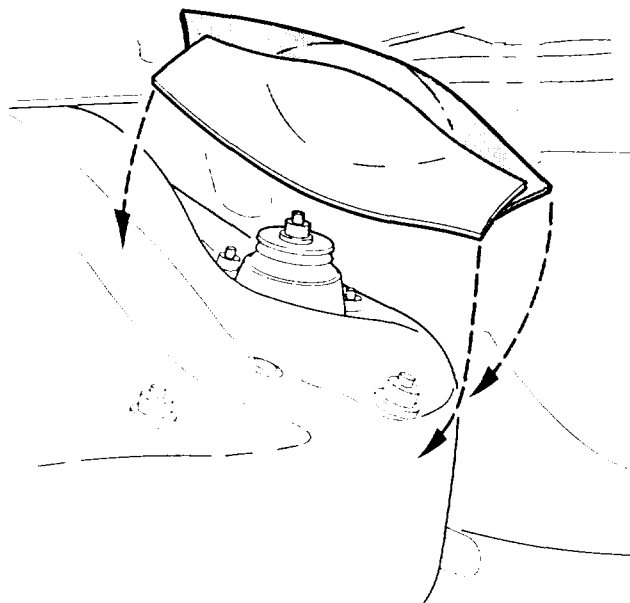
A jingling noise is heard from the rear when driving on bumpy roads.

The sounds of the rear suspension springs and damper valves working are being transmitted into the passenger compartment.

Insulate the top of the rear dampers with EPT.

1. Remove the trunk side trim panels.
2. Cut four 15-inch-long pieces of EPT 10T sealer.
3. Apply two overlapping pieces of the EPT 10T sealer over the top of a rear damper and mount. Leave some clearance above the center rod so the damper does not pull the sealer loose as it moves up and down.

4. Repeat step 3 on the other rear damper.
5. Reinstall the trunk side trim panels.
