# SERVICE BULLETIN

Model	Applicable To	File Under	Bulletin #
1988 - 93 PRELUDE	ALL	BODY	93-012
			Issue Date FEB 19, 1993

## Squeak From Center Console

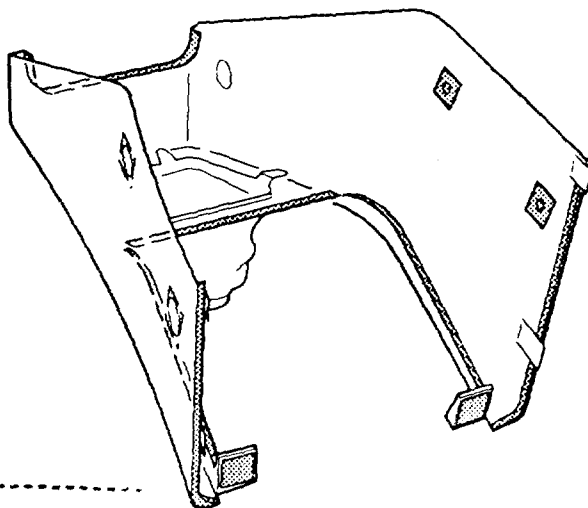
#### 1988-91 Prelude

A squeaking noise from the center console.

Friction between the center console and the instrument panel.

1. Remove the center console as described in the service manual.
2. Cut strips of adhesive-backed wool felt (P/N 06693-SA5-000). Apply them to all points highlighted in the illustration.

3. Reinstall the center console.
