SERVICE BULLETIN

Model 1994 - 95 PRELUDE	Applicable To ALL EXCEPT 'S' MODEL	File Under BODY	Bulletin No. 95-006
			Issue Date JAN 23, 1995

Jingling in the Left Side of the Dashboard

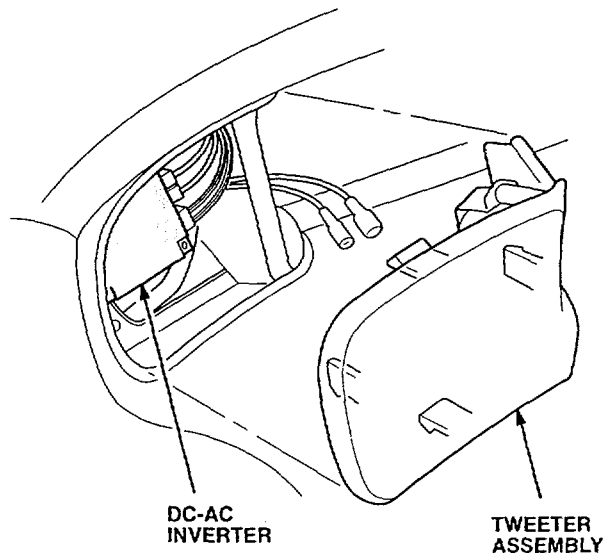
The housing of the DC-AC inverter is loose.

Remove the left tweeter assembly by carefully prying on its edges. Try to reproduce the noise either by tapping on the top of the dashboard with your fist, or by driving the vehicle on a rough road. If you can reproduce the noise, apply pressure to the DC-AC inverter. If the noise disappears, continue with CORRECTIVE ACTION.
