Model	Applicable To	File Under	Bulletin No
1994 - 96 PRELUDE	See VEHICLES AFFECTED	BODY	95-054
			Issue Date DEC 18, 199

Rattle From the Rear Headliner

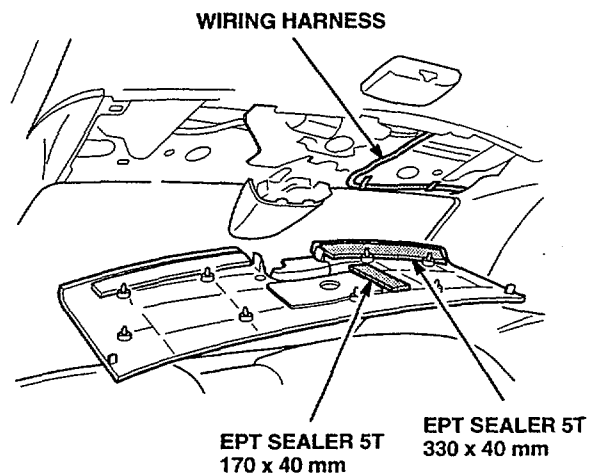
Vibration of the ceiling light/sunroof/high-mount brake light wiring harness against the rear headliner.

3. After removing the headliner, check the clips for damage and correct positioning. Reposition or replace clips as needed.
4. Cut two pieces of EPT Sealer 5T, one measuring 330 x 40 mm, and the other measuring 170 x 40 mm.
5. Peel off the backing and attach the EPT Sealer 5T to the underside of the rear headliner, between the headliner and the wiring harness.
