BUILDING INSPECTION

Address of Property: 1234 Franchise St, Fernwood

Date of Inspection: November 6th 2005

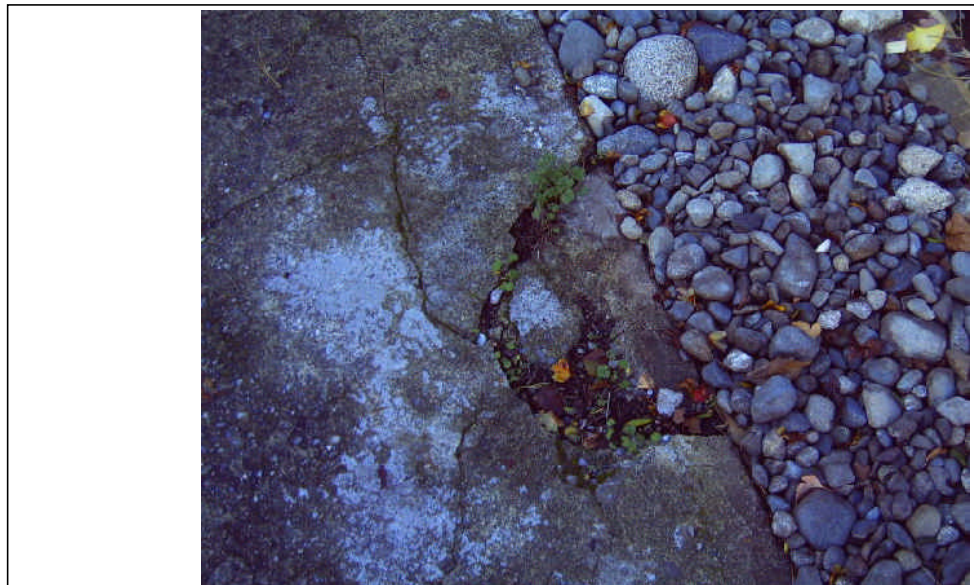
Attention Needed - Sections of the walkway are cracked and have broken up into segments.

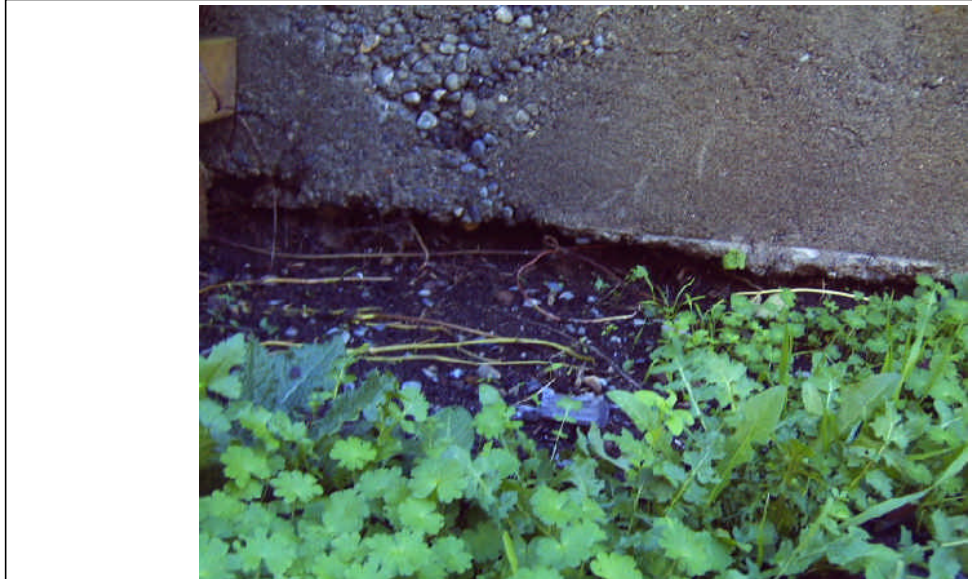
Attention Needed - The retaining wall at the rear is poorly supported, there are gaps underneath. The one on the right is satisfactory.

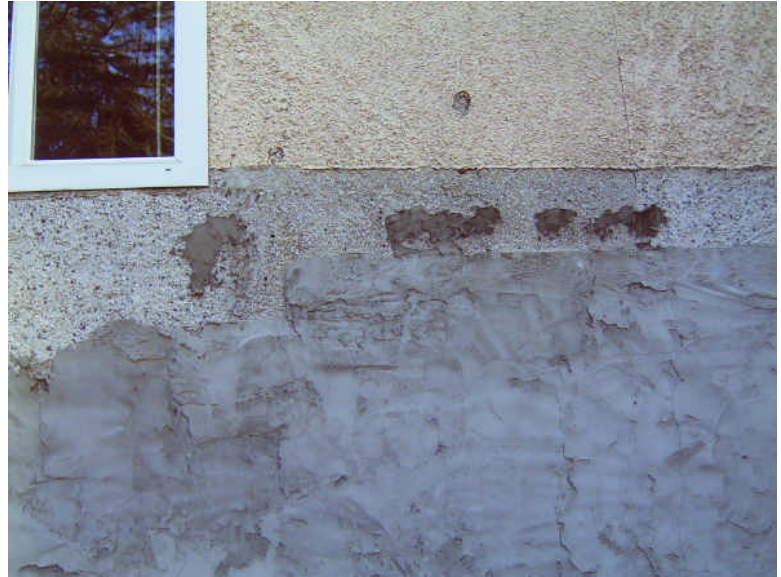
Attention Needed - The stucco has been poorly patched, it has staining from roof water leaks, it is cracked and it has different paint finishes.

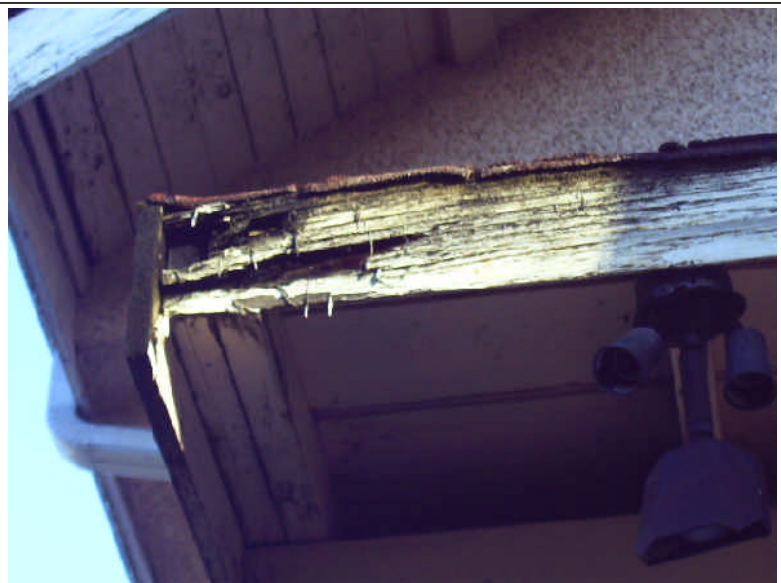
Action Necessary - The fascia & barge boards are rotting and the rot has affected the roof sheathing and the ends of the rafters. Repairs or partial replacement is needed.

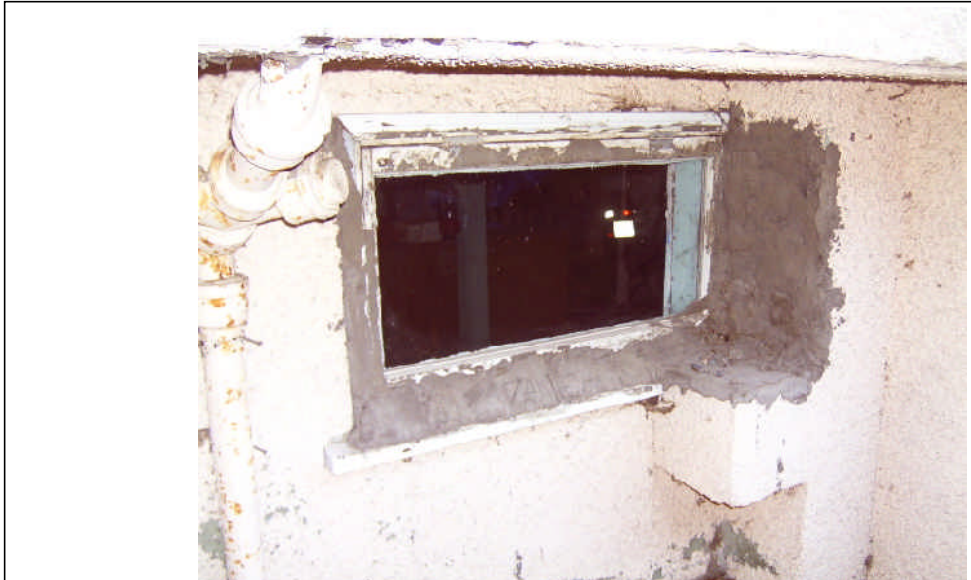
Action Necessary - One window has not been correctly installed and there are others with damaged/rotting frames and trim.

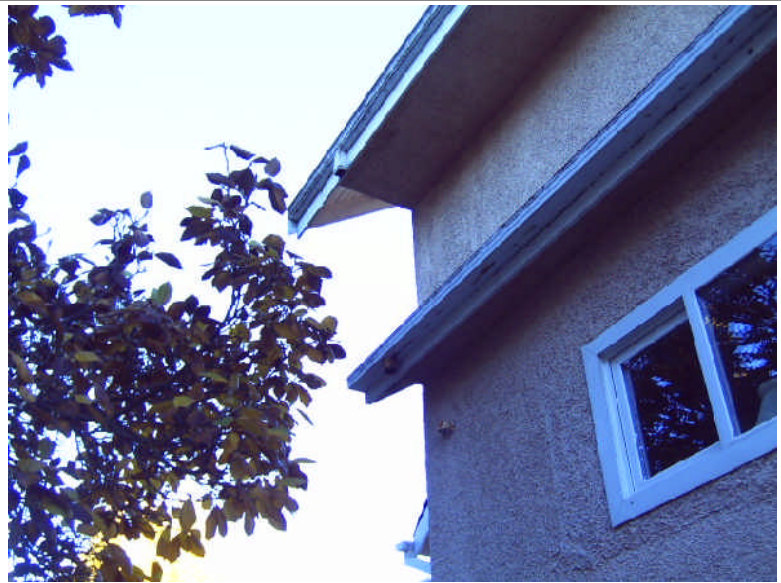
Action Necessary - Some downspouts are not working correctly due to sections missing.

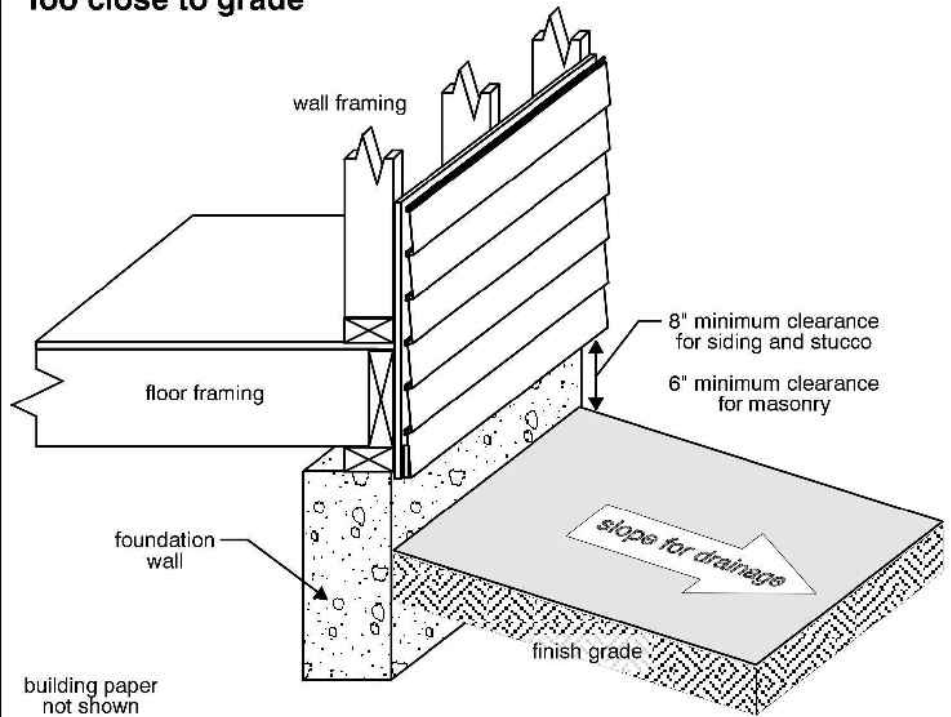
Too close to grade

Action Necessary - There is inadequate clearance between the soil and the siding. Any contact with the soil and siding increases the likelihood of rot and insect infestation.

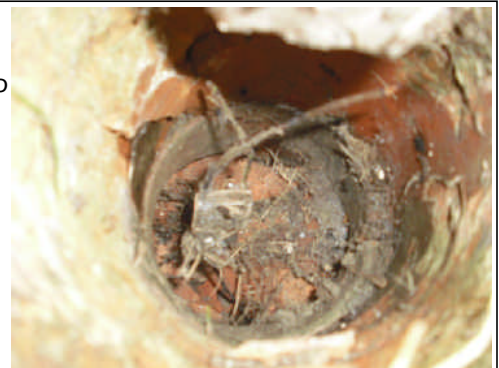
Action Necessary - the clay drain tile appears to be blocked. Recommend getting a specialist draitile company to clean out and scope the perimter draitile to establish it's presence and condition.

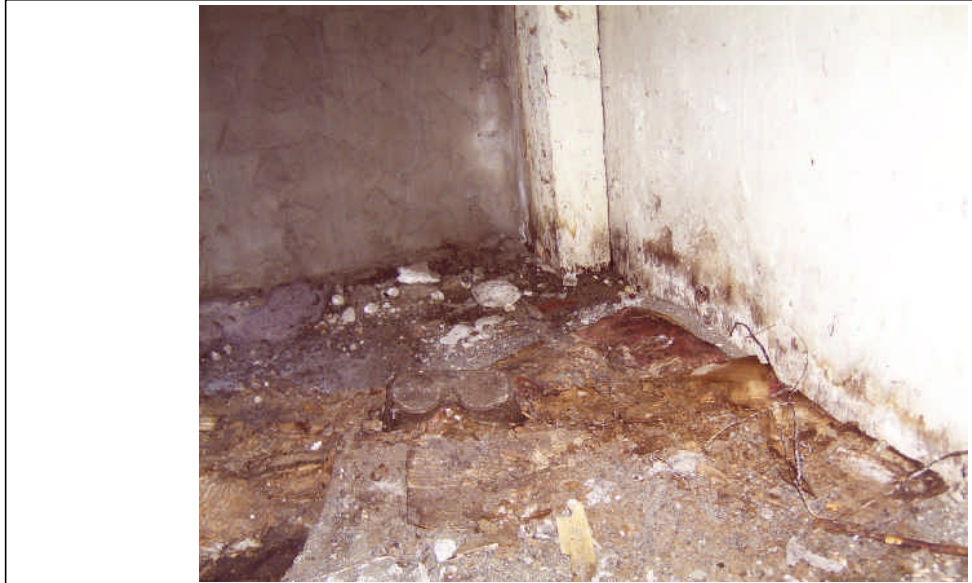
Action Necessary - there are rotting columns, access door and wall under the stairs.

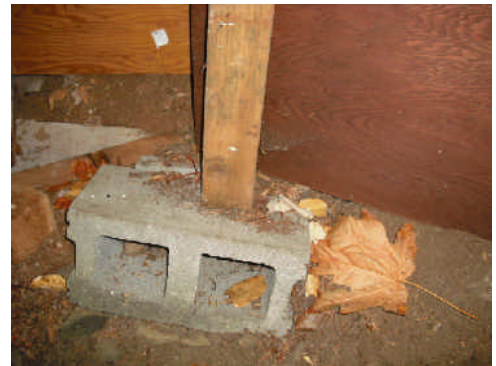
Action Necessary - the columns are poorly supported.

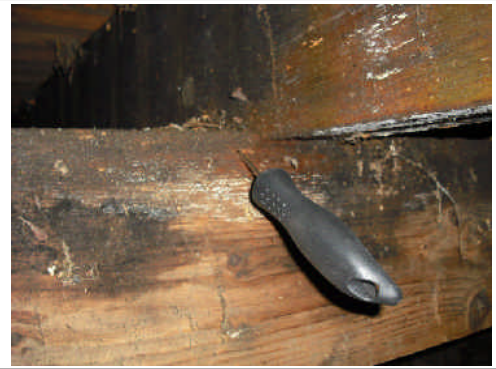
Action Necessary - The beams need repair or replacement. This is due to rotten sections.

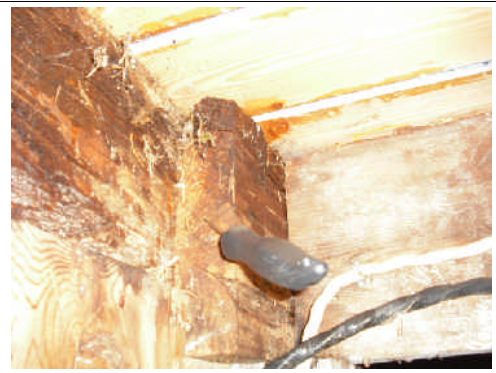
Action Necessary - The joists need repair or replacement. This is due to rotten sections.

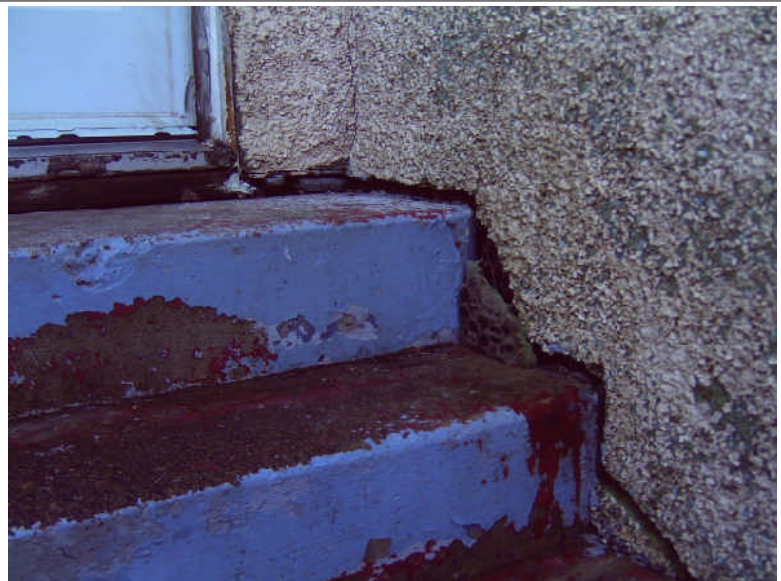
Action Necessary - The steps have settled and water is now getting into the house frame which is rotting.

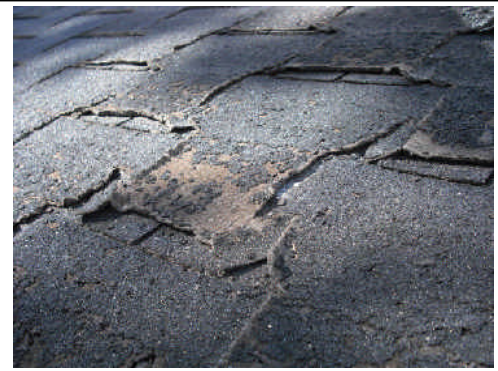
Action Necessary - The roof covering material needs replacing.

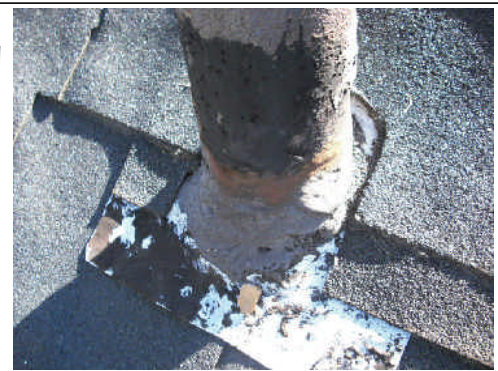
Action Necessary - the flashings are in poor condition and should be replaced when the house is re-roofed.

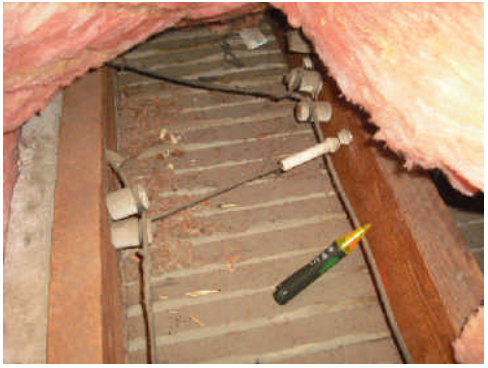
Circuit Wiring Type: Action Necessary - the older style knob and tube wiring is in use. This is likely to be an issue for your insurance company. Due to its age and increased circuit needs, it is suggested that consideration be given to upgrading the system to current standards. Estimates from a qualified licensed electrician would be needed.

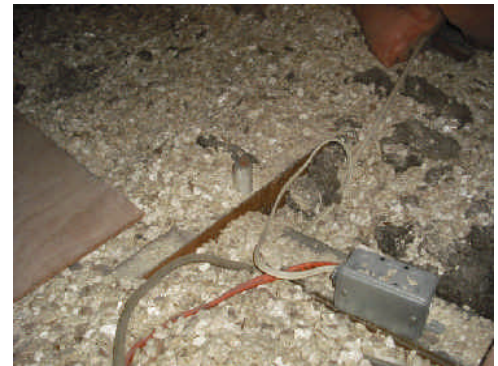
Note: some types of vermiculite contain asbestos. It is recommended that this type of insulation is not disturbed. If it becomes a requirement to disturb it then chemical analysis will be required to determine if it contains asbestos. In which case, if it does, specialist asbestos removal contractors will be required.

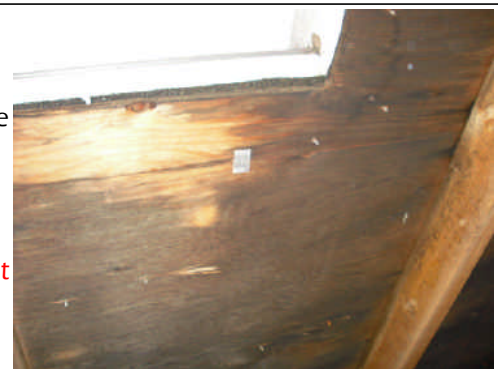
Action Necessary - There either is or has been a moisture problem in the attic that requires attention. This is evidenced by staining on the underside of the roof sheathing and on the trusses/rafters and rusty nails where they penetrate the sheathing. **It is strongly recommended that the services of an environmental consultant are used to identify the staining (could be mould etc) and what course of action should be undertaken. You should also establish where the moisture is coming from.**

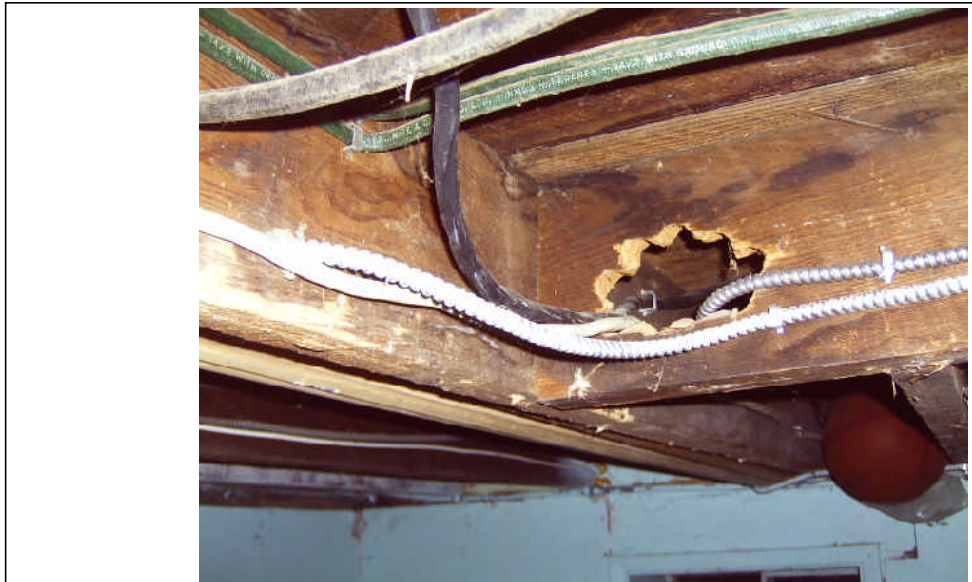
Action Necessary - There was evidence of insect infestation in some joists. Also noted were large holes for cable routes.

Also note some joists were sloping and poorly fixed at the ends.

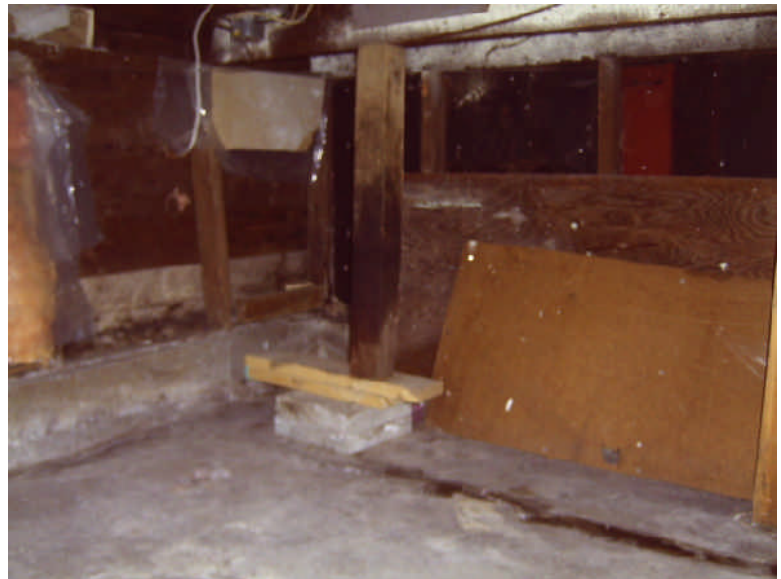
Attention Needed - At least one column supporting an overhead beam in the basement needs some attention.

Also note columns are missing near the stairs.

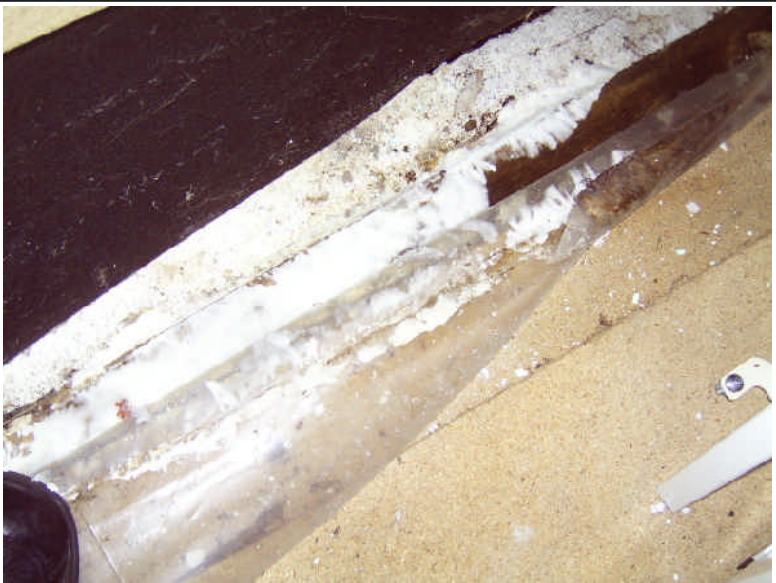
Yes - Cracks were noted in the slab floor. Also note some areas were soil covered with wood. Fungus was noted growing out of the floor.

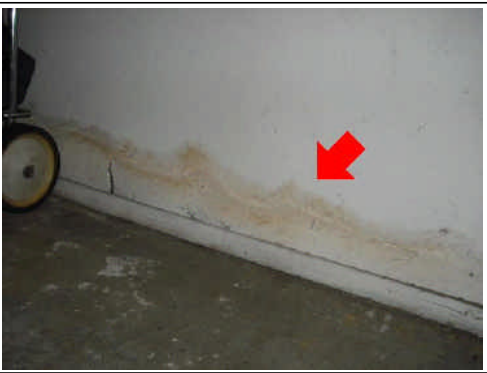
Action Necessary - There is evidence of water entry in the basement level.

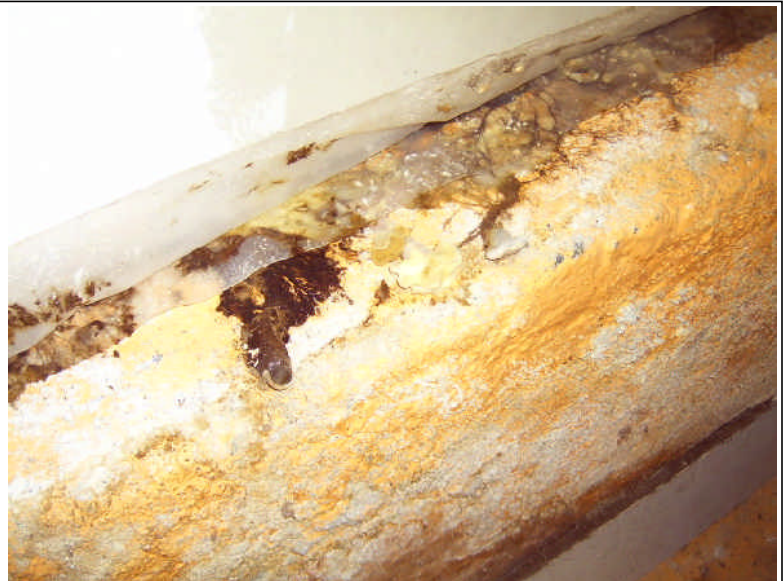
Attention Needed - Sections of the exposed wall framing members were rotting. Fungal growth could be seen growing out from enclosed wall framing.

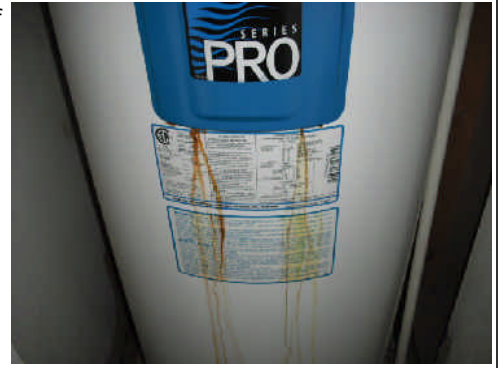
Action Necessary - There is evidence of deterioration due to rust or leakage. Replacement is recommended.

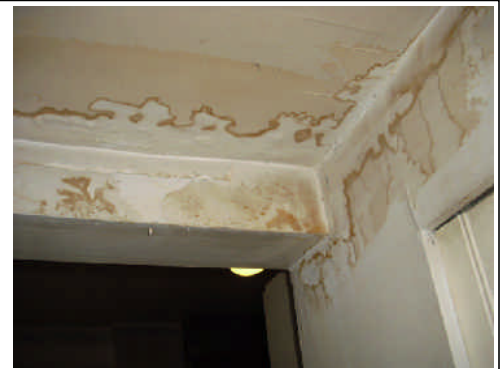
Attention Needed - there is water staining due to a leak from the roof.
