BUILDING INSPECTION

Address of Property: 31 Olive Street, Oak Bay

Date of Inspection: July 17th 2006

Client: Ivan House

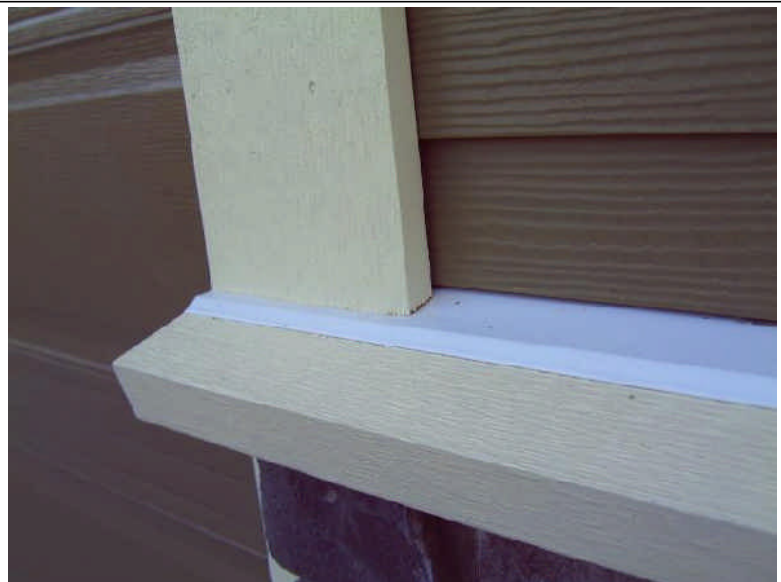
Action Necessary - It is good practice to have a gap where siding or trim meet horizontal flashings to prevent water from 'wicking up'. The gaps around the flashings on this house were poor (and in some instances none existing).

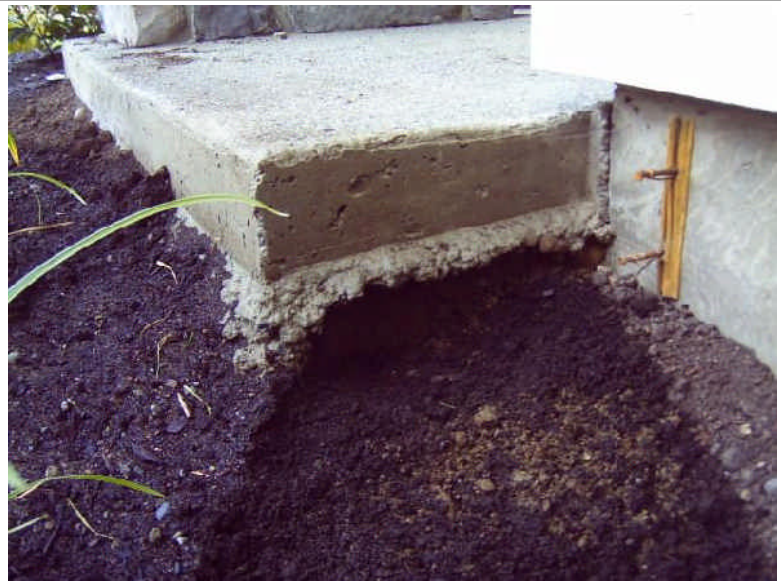
Action Necessary - The edges of the concrete porch floor are inadequately supported. This will eventually cause the concrete to crack.

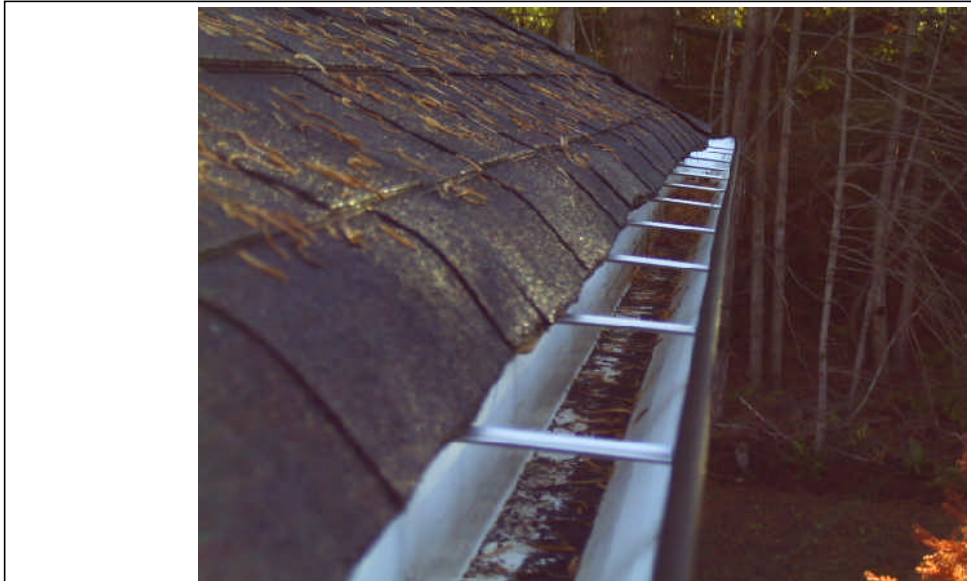
Gutters:

Attention Needed - The gutters need cleaning out. It is also prudent to re-caulk all the joints periodically.

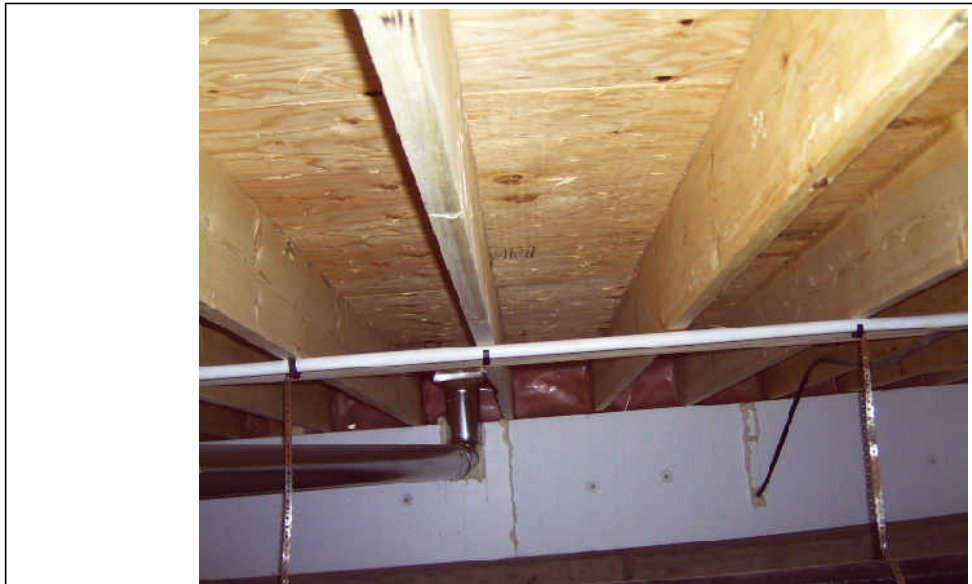
Floor Joists Condition:

Attention Necessary - some of the larger joists spans didn't have any cross bracing.
