Crest Building Consultancy Ltd
5382 Parker Avenue
Victoria
V8Y 2M9
Tel: (250) 888 9182
Fax: (250) 727 3723
Email: leeottewell@shaw.ca
Web: www.crestbc.ca

BUILDING INSPECTION

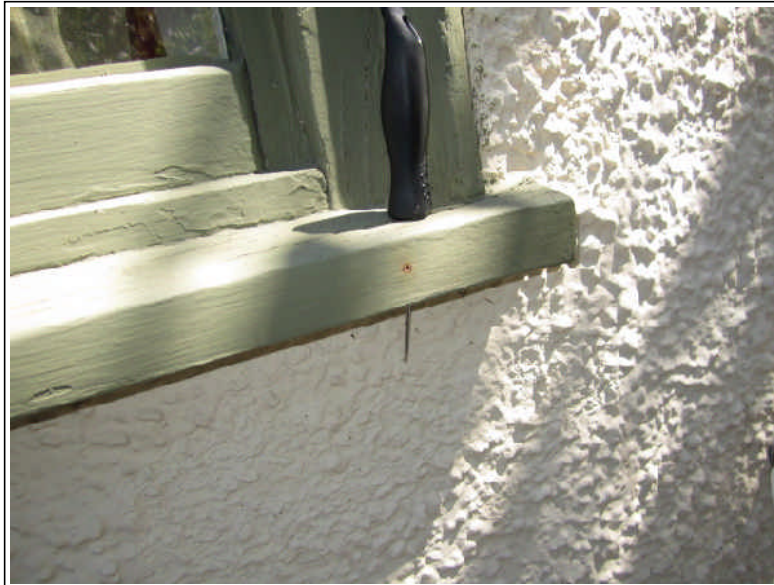
Action Necessary - There is sections of rot in some window frames.

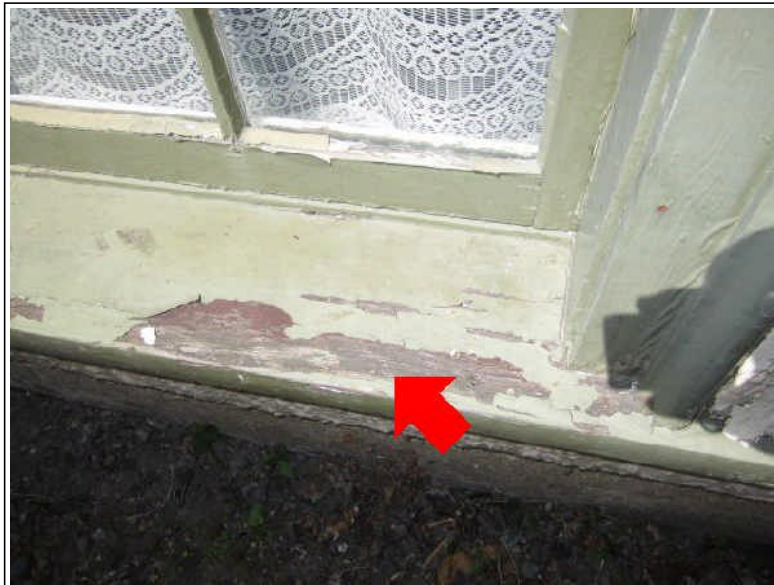
Attention Necessary - Some exposed wooden surfaces are in need of painting/staining.

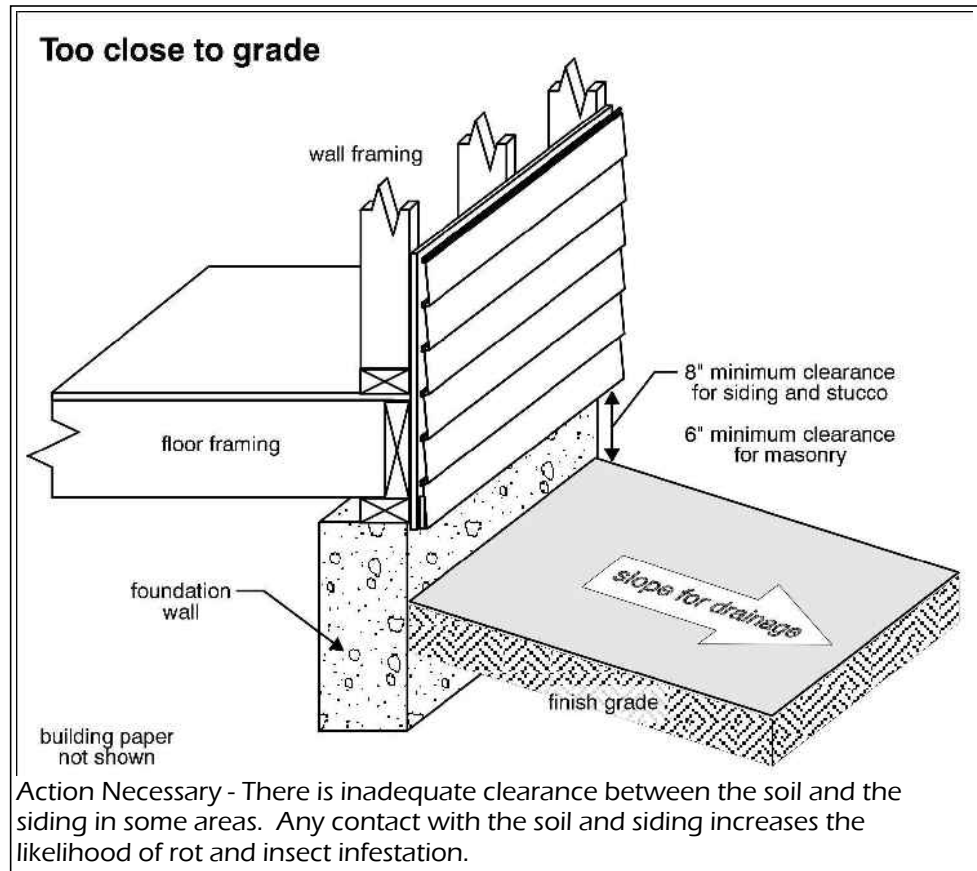
Siding Too Close to Grade:

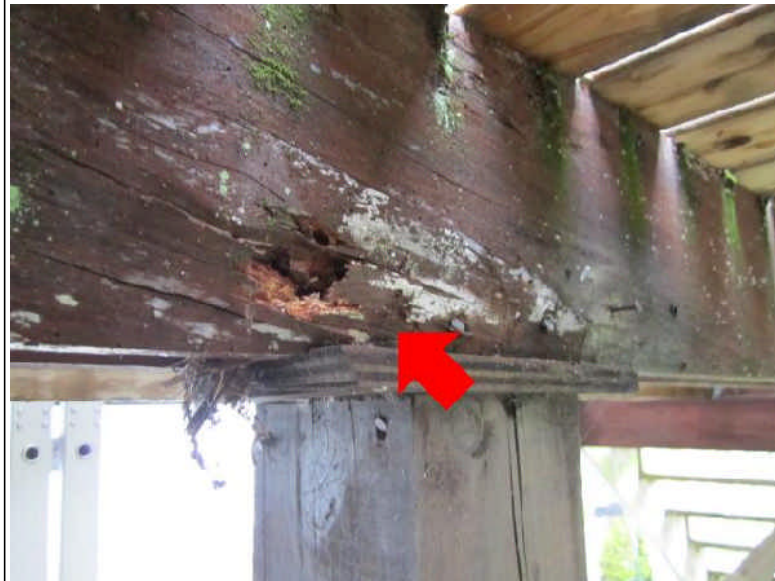
Action Necessary - Sections of the beam(s) are rotten.

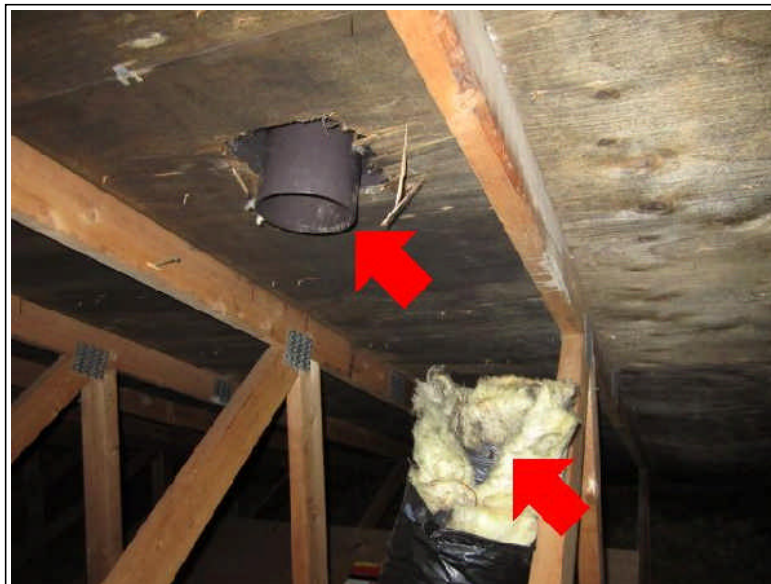
Action Necessary - A dryer vent is discharging into the attic space. Mould has formed on the underside of the roof sheathing. **It is strongly recommended that the services of an environmental consultant are used.**

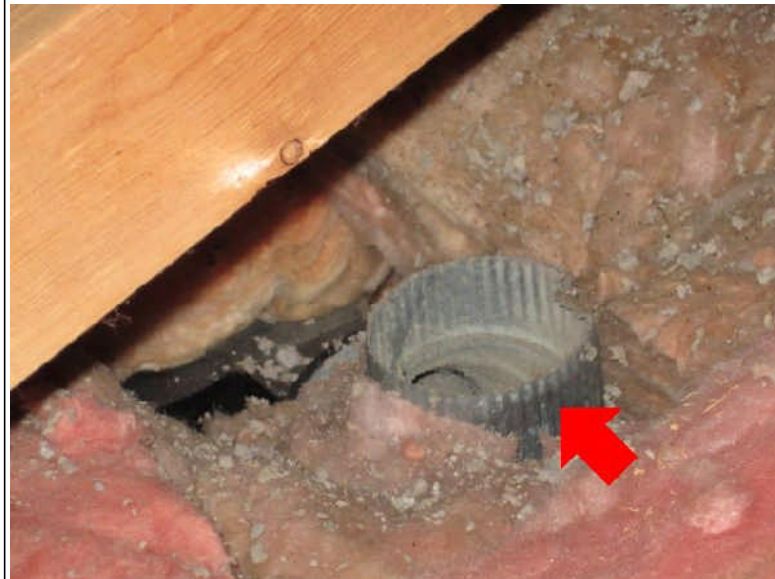
Action Necessary - The kitchen range hood is allowing moist air to enter the attic. It is essential to direct all vent ductwork to the outside so that additional moisture is not introduced into the attic space and insulation.

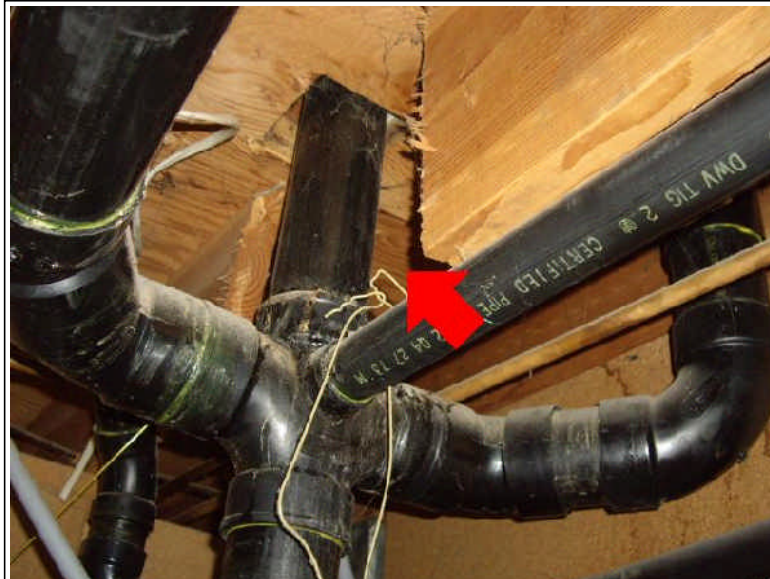
Action Necessary - A joist has been cut to accommodate plumbing.

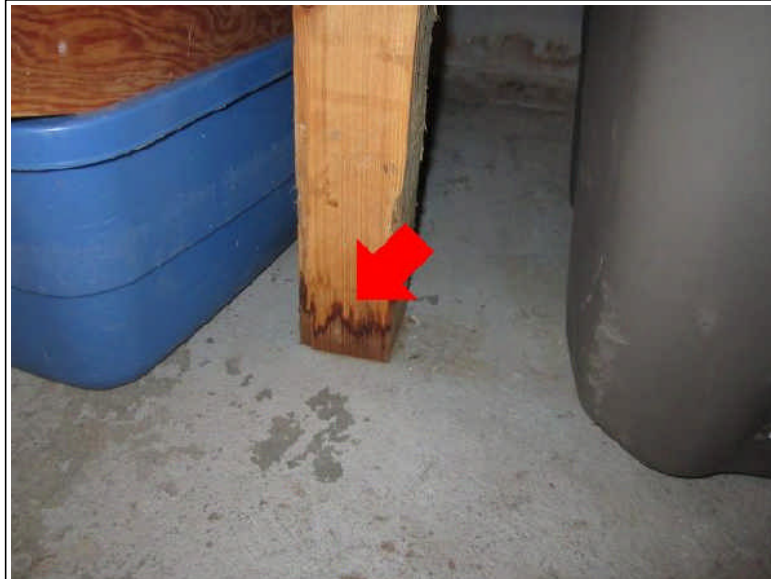
Attention Necessary - Staining was noted. These areas are now dry which makes it difficult to determine if the damage was caused by a prior leak or ongoing water penetration.

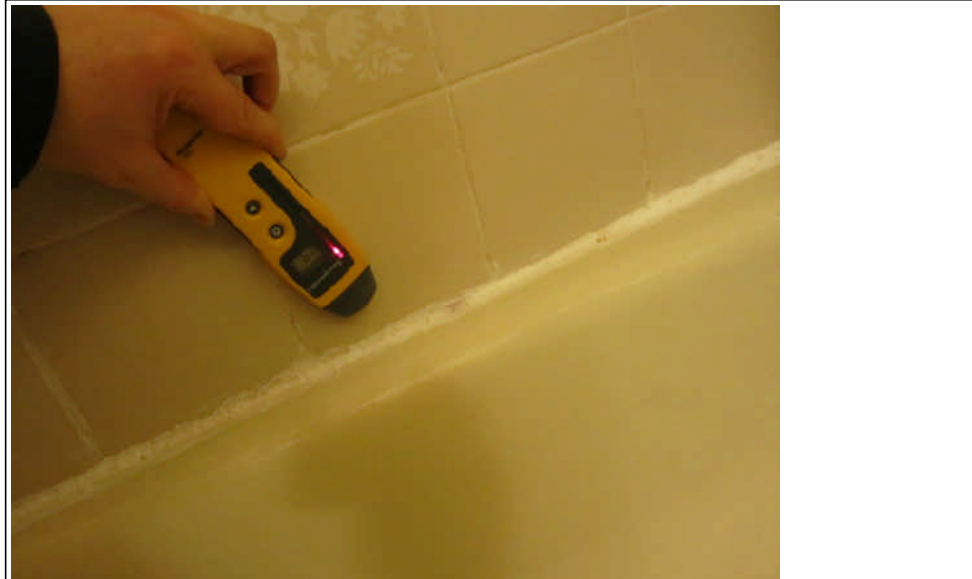
Attention Needed - The moisture levels were very high around the bathtub. There is likely to be concealed damage.
