Applies To: 1997 – ALL except Passport

JAN 20, 1997

Removal of "Clear Guard" Protective Film

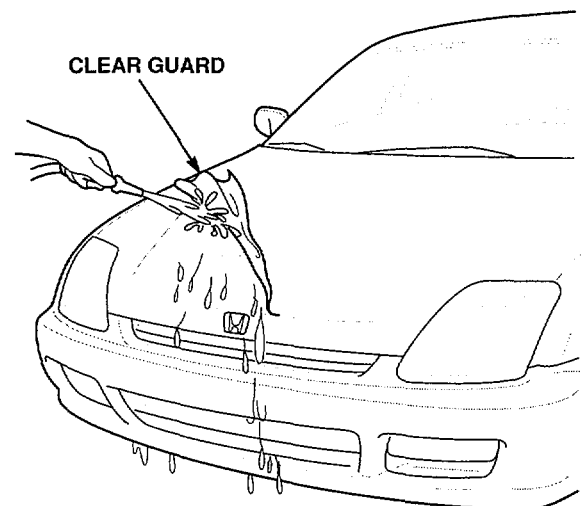
3. While you wear eye protection, spray underneath the film to lift it off in large sheets. Do not point the spray nozzle at moonroof moldings or other roof seals. If the film stretches like a balloon when you remove it, the panel is still too hot. When this happens, spray the panel with cool water, then continue to lift off the film.

1. Move the car into the shade. Spray cool water on the whole car for at least one minute.
2. On the edge of a panel (hood, roof, trunk, or fender), loosen the edge of the protective film with your fingernail, and spray the panel with a high-pressure washer.

4. Repeat steps 2 and 3 on the rest of the panels.
5. Make sure you remove all of the protective film from the car. If some of it remains between the fenders and the doors, or under the edges of the hood and the trunk, wipe it off with a wet terry cloth towel.
