SERVICE BULLETIN

Model 1992 - 93 PRELUDE	Applicable To ALL	File Under BODY	Bulletin No. 93-001
			Issue Date JAN 15, 1993

Loose Door Seal

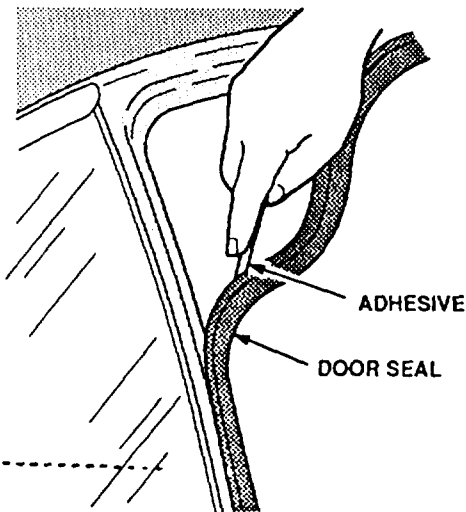
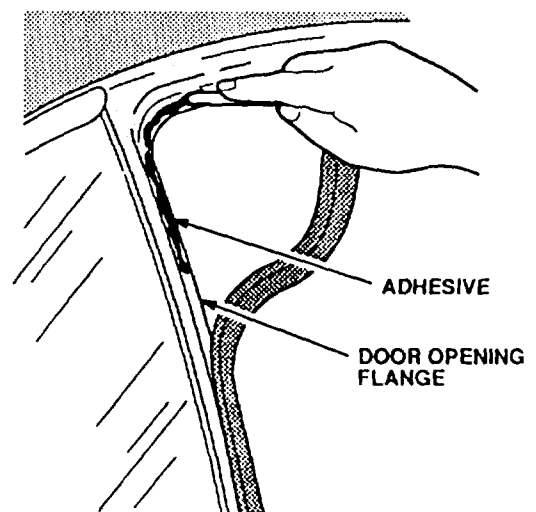
The seal around the door opening has come loose from the body.

1. Pull the door seal away from the door opening flange in the affected area. Clean the door opening flange with 3M General Purpose Adhesive Cleaner (P/N 051135-08984) or equivalent.
2. Apply a *thin* coat of 3M Weatherstrip Adhesive (P/N 051135-08011) to the door seal and to the door opening flange. Allow the adhesive to dry until tacky.

3. After allowing the adhesive on both surfaces to become tacky, press the door seal back in place on the door opening flange.
