BUILDING INSPECTION

Address of Property: 1234 Franchise St, Fernwood

Date of Inspection: November 6th 2005

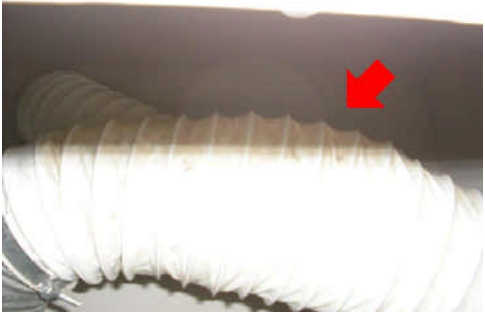
Template Laundry:

Linen Closet:	Satisfactory - The closet is functional and of average size.
Walls:	Satisfactory - The walls in this room appear to be satisfactory.
Ceiling:	Satisfactory - The ceiling is functional and as expected.
Floor:	Satisfactory - The floor in this room is in satisfactory condition.
Windows:	Action Necessary - The thermal seal in at least one window is noted as deficient. Although the window is still keeping the rain out, the staining between the panes of glass will continue to cloud the glass. At some time, if left in place, the window will turn opaque. Replacement is recommended since it is no longer serving its intended function.
Electrical Outlets:	Action Necessary - At least one outlet in the room is cracked.
Light and Light Switch:	Satisfactory - The light(s) and switch(es) were functional at the time of the inspection.
Dryer Ventilation:	<p>The dryer has a plastic vent. For safety reasons it is prudent to change this to metal to reduce the risk of fire which could be caused by a build up of lint inside the vent.</p>
